Mining data to identify problems, improve performance takes perseverance, know-how

Case history

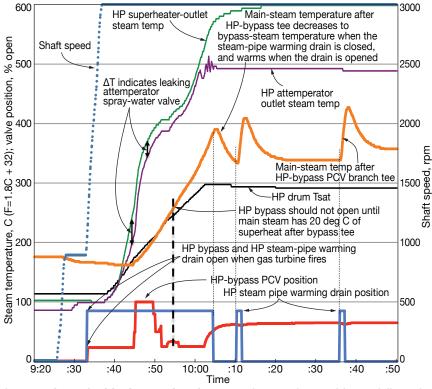
3. Data plots of critical operating data over time are for a cold start followed by open-cycle service

Fig 3 presents key historian data for a cold start followed by open-cycle operation. This unit has no GT bypass stack, so open cycle here means the HRSG is producing steam that is routed to the condenser via the HP and IP steam-turbine bypass systems. Below are thumbnails for each of the three operating conditions and system/equipment line-ups considered by Anderson as contributors to HP-bypass PCV erosion.

No. 1. The HP-bypass PCV (red line) and main-steam-pipe warming drain (bright blue) open immediately when the GT fires at 9:33. Main-steam

temperature (orange) measured 46 ft downstream of the PCV branch tee tracks Tsat (black) until 9:53. As the main-steam pipe warms it forms condensate. When the PCV is open during the warm-up period, some or all of this condensate may pass through the PCV.

No. 2. During early startup (9:41 to 10:03), the HP attemperator block and control valves are closed (not shown in Fig 3), but the HP superheater outlet (attemperator inlet) steam temperature (green) is consistently higher than the attemperator outlet steam temperature (purple). This is characteristic of spray water leaking into the main-steam pipe.

There is a small-bore drain located on the main-steam pipe after the attemperator that is open during startup; but once steam flow begins pushing the leaking spray water along the pipe it likely will bypass the drain and some may be ingested by the PCV.

No. 3. The main-steam pipe, from the HP-bypass branch tee to the ST inlet valves has a 1% downward slope, as shown in Fig 1. A drain pot is located 58 ft downstream of the bypass branch tee; it has a 3-in. automatic drain valve (bright blue) and serves as the main-steam-pipe warming drain.

When open-cycle operation begins at 10:04 this valve closes, and the main-steam temperature measured about 46 ft downstream of the bypass tee (orange) begins to cool to the steam temperature measured after the HP- bypass PCV and its desuperheater.

At 10:11 and 10:36 the warming drain valve automatically opens for a couple of minutes. This indicates that sufficient condensate has formed in the section of deadheaded pipe between the HP-bypass tee and the ST inlet valves to trigger the warming drain-pot level switch. Each time the warming drain valve opens, mainsteam temperature measured 46 ft downstream of the bypass tee quickly heats up to more than 400C.

The main-steam pipe thermocouples installed 46 ft downstream of the bypass tee are located on top of the steam pipe. Data suggest condensate forming and pooling in the bottom of the deadheaded main-steam pipe causes a top-to-bottom temperature difference that bows the pipe upwards, overcoming the 1% downward slope and causing condensate to run back towards the bypass branch tee where it is ingested by the PCV.

Corrective actions:

- Delay opening the HP-bypass PCV until the main-steam temperature measured downstream of the bypass tee increases to 20-deg-C above Tsat.
- Repair the leaking HP attemperator spray and block valves.
- Leave the main-steam-pipe warming drain open during open-cycle operation. This may require modulating the drain valve's position to limit steam flow while avoiding condensation in the deadheaded section of pipe.
